# AEROPRAKT INFORMATION BULLETIN

## INSPECTION AND REPAIR OF THE FRAME NO.2 OF A-20 (R582) AIRCRAFT. IB A-20-01

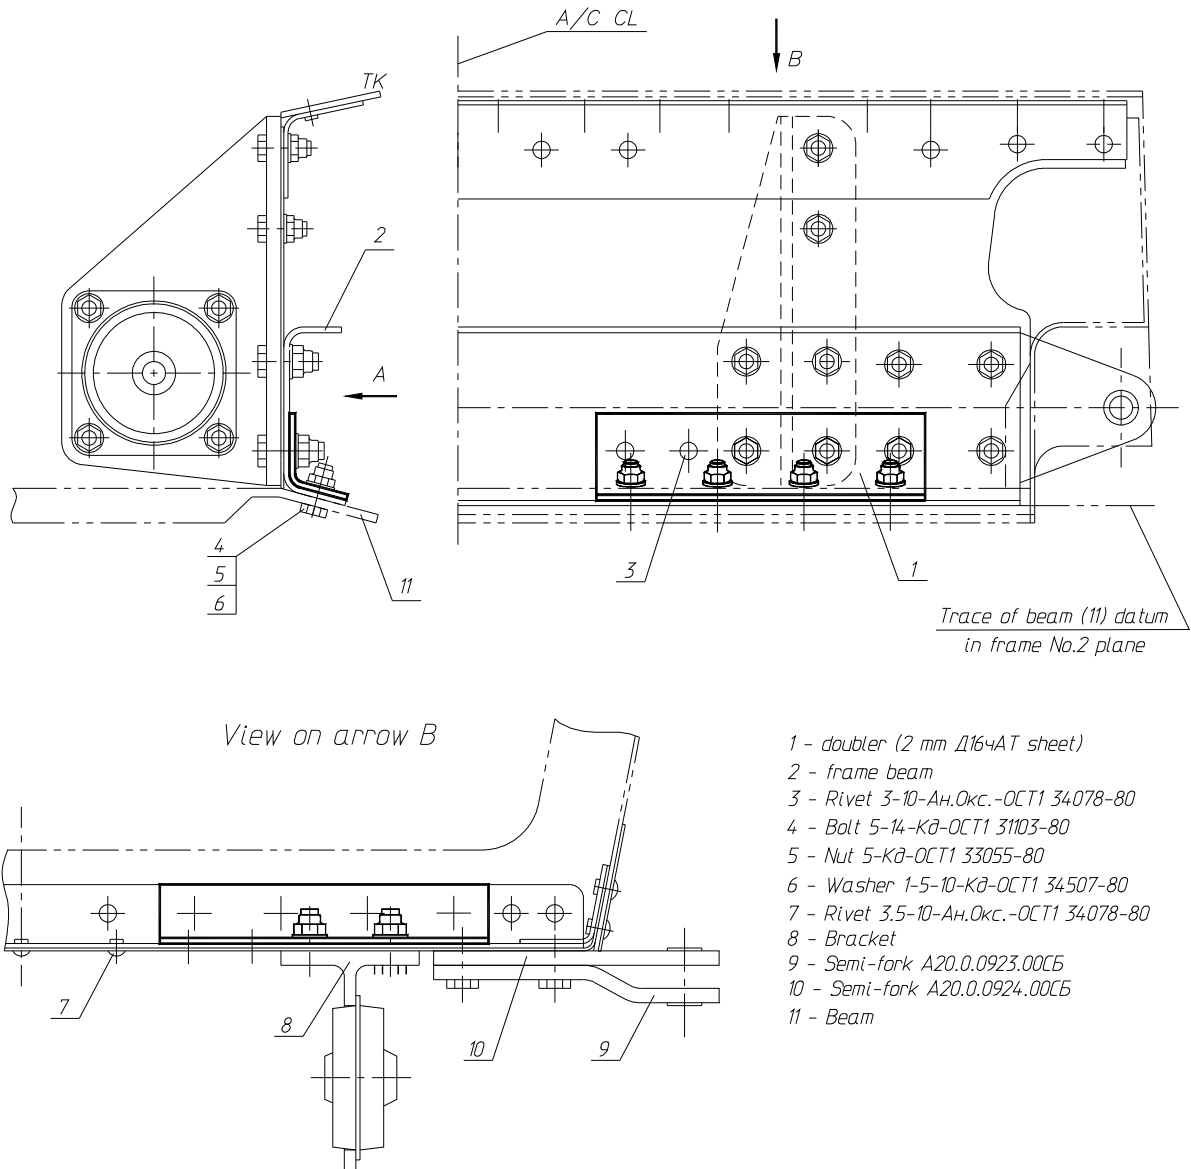
**Fig. 1**

It has been found out, that the reason of the crack in the frame No.2 beam is the vibration from the engine.

In order to prevent creation or growth of cracks it is recommended to install the doubler (item 2, see para 2.2) on the frame No.2 as shown in fig. 1.

- 1) remove the engine and engine mount;
- 2) remove the brackets (item 8);
- 3) remove the semi-forks (items 9, 10)
- 4) drill out the rivets (item 7);
- 5) drill the ends of the crack (if any) with  $\varnothing 4$  mm drill;
- 6) install the doubler (item 1) using CLICOs;
- 7) drill the doubler at bolt holes;
- 8) reinforce the beam (item 11), i.e. add 5 plies (each 0.3 mm thick) of fiberglass and replace the rivets to  $\varnothing 3.5$  (item 7);
- 9) fasten the doubler (item 1) with the rivets (item 3).
