AEROPRAKT INFORMATION BULLETIN

INSPECTION AND UPGRADE OF THE NOSE LANDING GEAR LEG OF A-22L2 AIRPLANES. IB A-22L2-01

MANDATORY

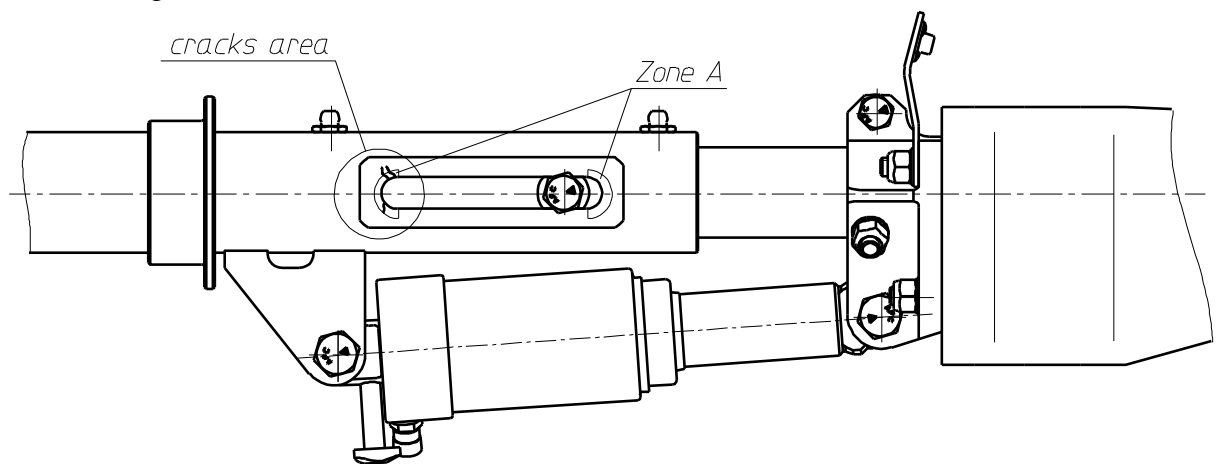
Fig. 1

It was found out that in case of intensive operation of the airplane on hard surface runways fatigue cracks may appear in the tubular part of the nose landing gear leg.

1. To make inspection easier put a support under fuselage in the area of the firewall so that the nose wheel is separated from the ground.
2. Remove the protective plastic cover after cutting with nippers two cable ties.
3. Remove the excessive grease, inspect the nose landing gear leg for cracks in the specified area (see fig. 1).

If any cracks are found contact the Manufacturer. If no cracks are detected perform the upgrade of the leg in accordance with 3.1.2. and perform periodically (according to the AMM) inspection of the nose landing gear leg.
