# **AEROPRAKT SERVICE BULLETIN**

## **№ SB A22LS-19**

### **REPLACEMENT OF THE NOSE WHEEL FORK HINGE BRACKET OF A22LS AND A22L2 AIRCRAFT**

**Model: A22LS and A22L2**

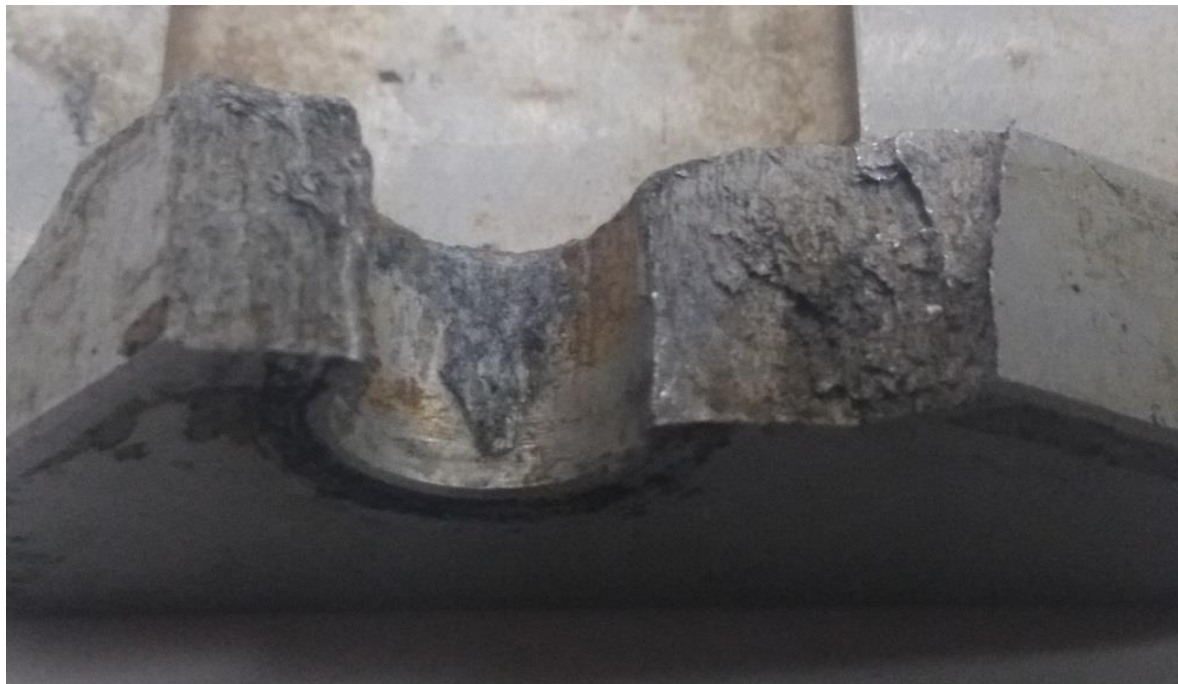
**Photo 1**

In conditions of high humidity and insufficient lubrication of the inner surface of the bracket hole (see photo 1) in the area of contact with the steel bolt, intergranular corrosion may appear, which affects significantly the bracket strength and may cause its disintegration.

**If case if the intergranular corrosion is detected in the bracket, stop operation of the aircraft until replacement of the bracket.**
